Above the Flood: Elevating Your Floodprone House

FEMA 347 / May 2000

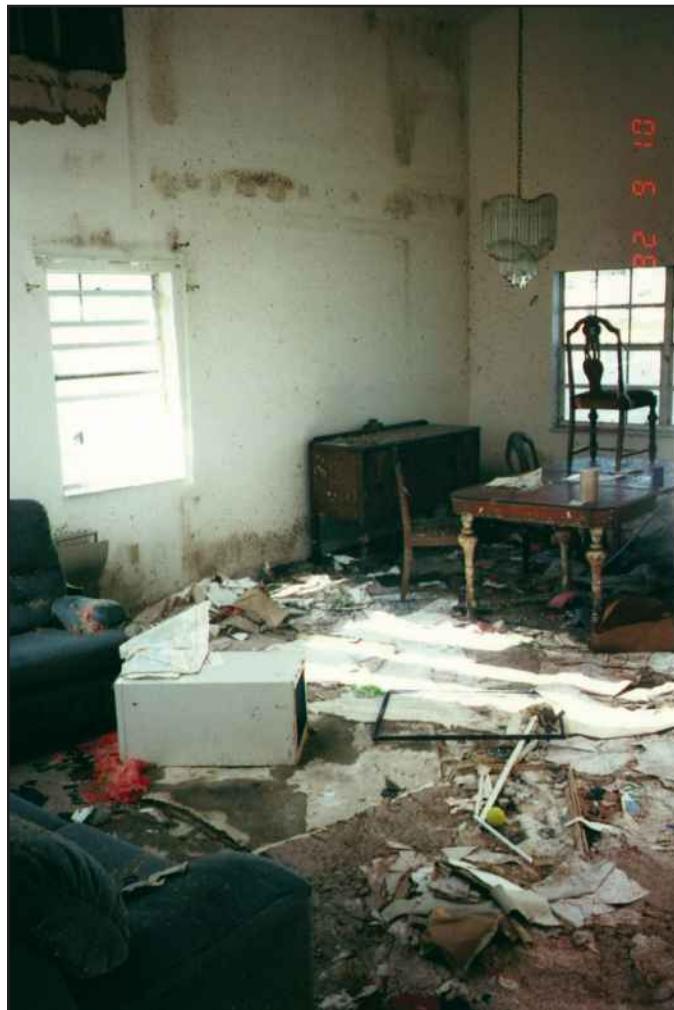
Figure 4

In low-lying areas, wind and rain damage to interior finishes and furnishings was exacerbated by flood waters.

The widespread destruction caused by Andrew was due primarily to high winds (Figure 3). However, flood waters contributed to the damage in low-lying coastal areas of central and southern Miami-Dade County (Figure 4).

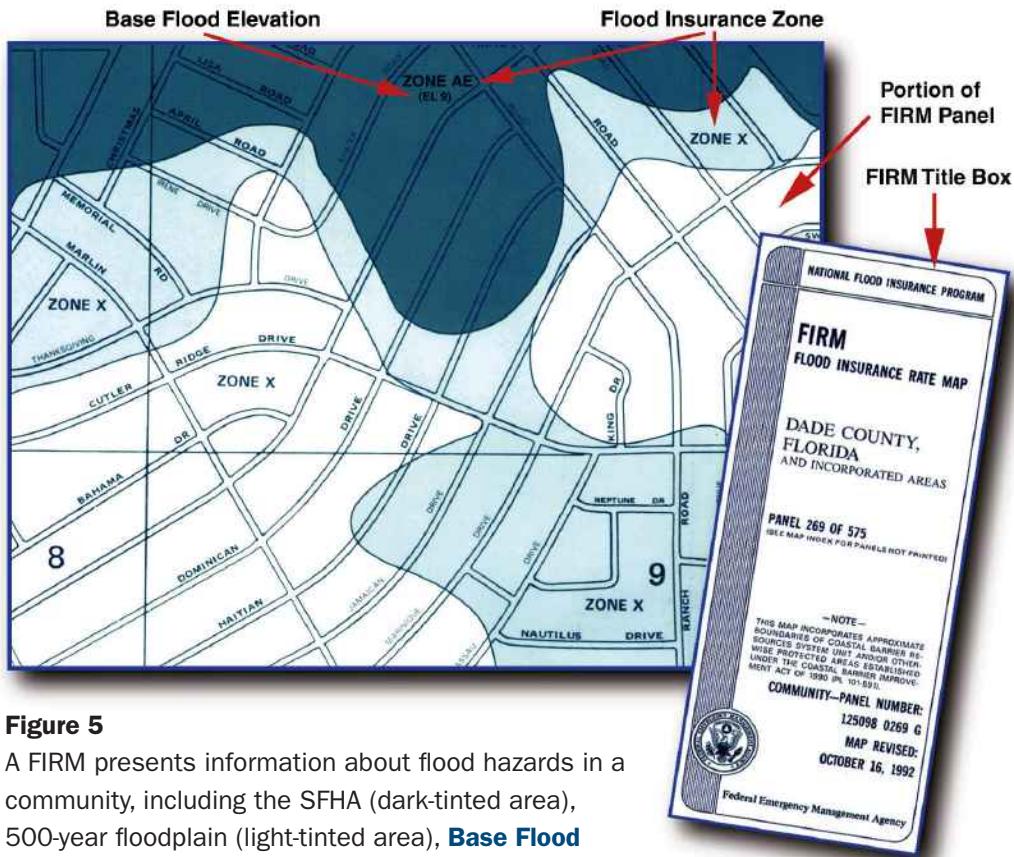
**Figure 5**

A FIRM presents information about flood hazards in a community, including the SFHA (dark-tinted area), 500-year floodplain (light-tinted area), **Base Flood Elevation** (number in parentheses), and flood insurance zones (AE and X in this example).

Note that the SFHA in the example in Figure 5 is designated Zone AE. This zone is only one of several applied to SFHAs under the NFIP, including V, VE, V1-V30, A, AE, A1-A30, AO, and AH. These zones indicate differences in the types and severity of flood hazards in SFHAs. For the purposes of this publication, it is sufficient to focus on the basic differences between the two main types of SFHA zones—V zones and A zones. The distinction is important because regulatory requirements associated with V zones and A zones differ significantly. As explained later in this chapter, these requirements affect the types of building elevation techniques that may be used under the NFIP.

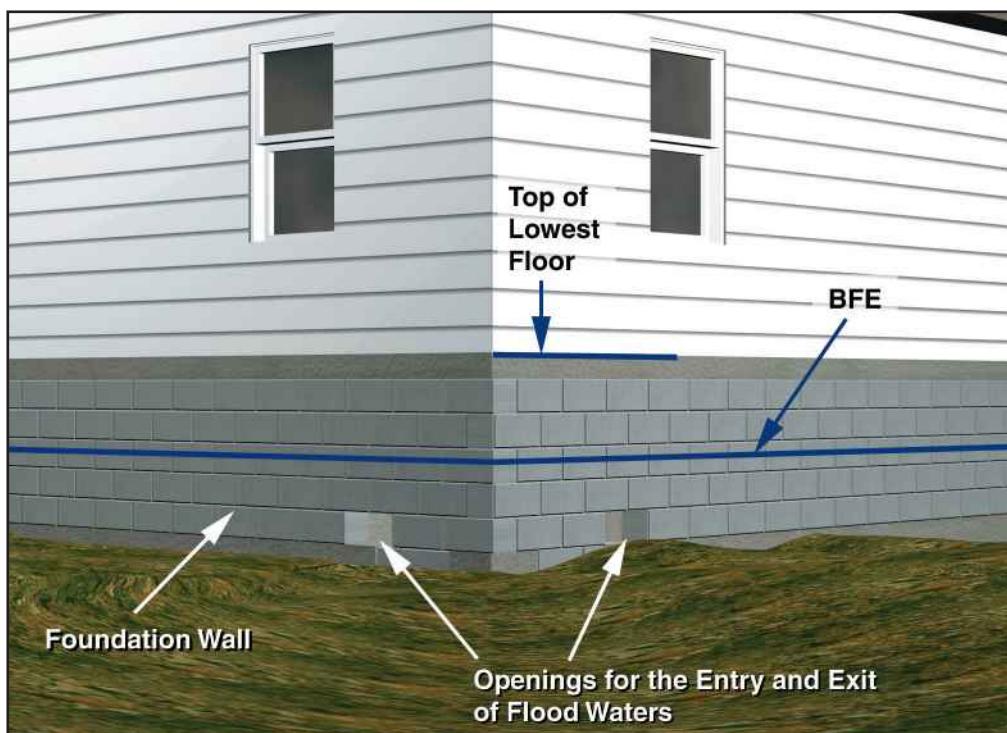
Figure 6

In a new, substantially improved, or substantially damaged building in an A zone, the elevation of the lowest floor must be at or above the BFE.

In A zones, where flood hazards are less severe, buildings may be elevated either on an open foundation or on continuous foundation walls below the BFE (Figure 6). Regardless of the type of foundation used, A-zone buildings must be elevated so that the **lowest floor** is at or above the BFE, as shown in Figure 6. If continuous walls are used below the BFE, they must be equipped with openings that allow flood waters to flow into and out of the area enclosed by the walls (Figure 6). Allowing the entry and exit of flood waters ensures that water pressures will be the same on both sides of the walls and reduces the likelihood that water pressure will cause the walls to fail.

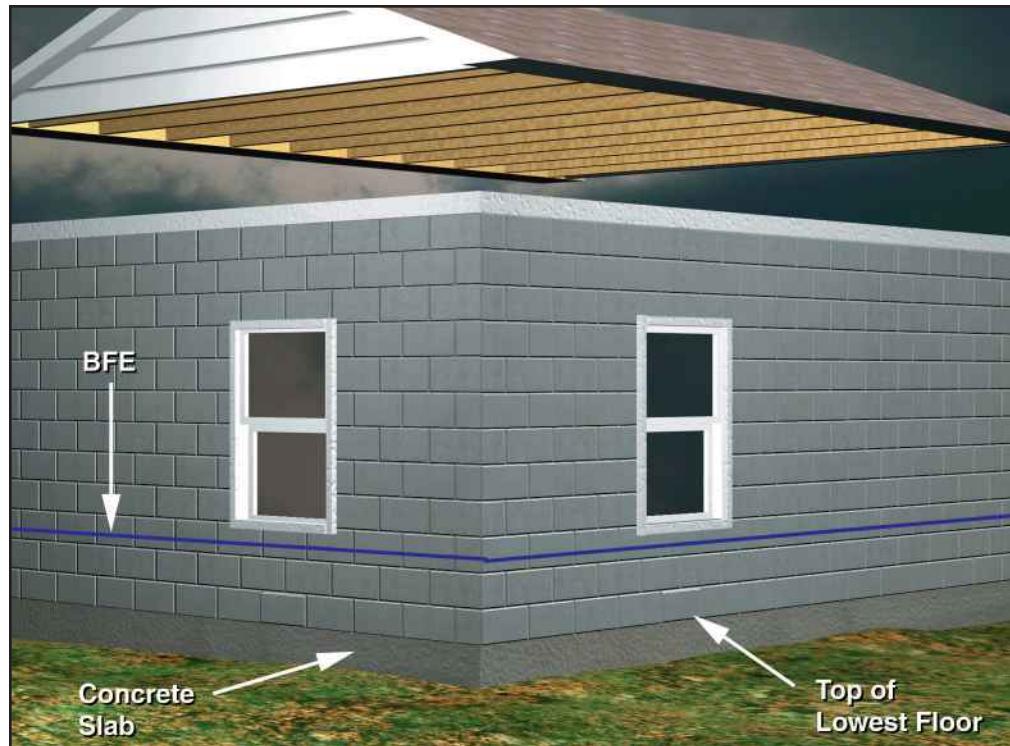
Figure 10
The first step in
Technique 1 is
removing the roof.

Technique 1 is appropriate for houses with concrete or masonry walls, but not for houses with other types of walls, such as those framed with wood studs, which would be more vulnerable to flood damage. This technique is usually appropriate when the depth of the base flood at the house is no more than 4 or 5 feet above grade. The elevation process begins with the temporary removal of the roof and roof framing, in a single piece if possible (Figure 10). This is commonly done with a crane. The roof is then stored on site so that it can be reinstalled later. The next step is to remove the windows and doors.

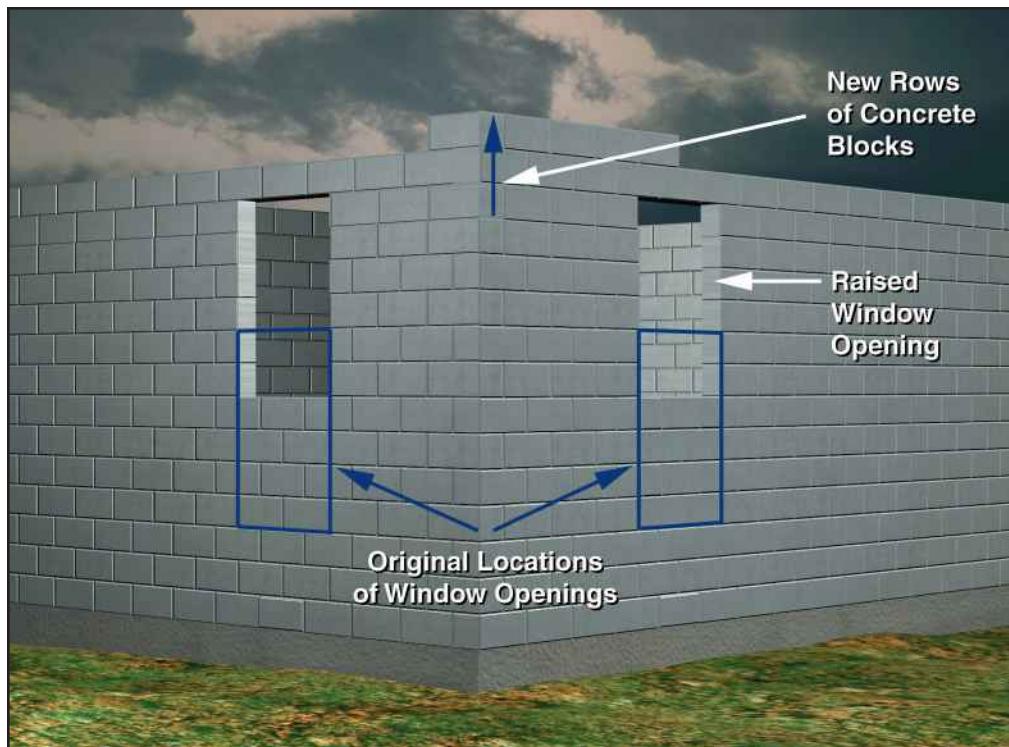
The tops of the walls and bottoms of the window openings are raised with concrete blocks.

After the roof, windows, and doors are removed, several courses of concrete block are added to the tops of the existing walls and to the bottoms of the window openings (Figure 11). A corresponding number of blocks are removed from the tops of the window openings so that the size of the windows will remain the same. In addition, although not shown in Figure 11, concrete bond beams are formed in place at the tops of the extended walls to provide structural reinforcement.

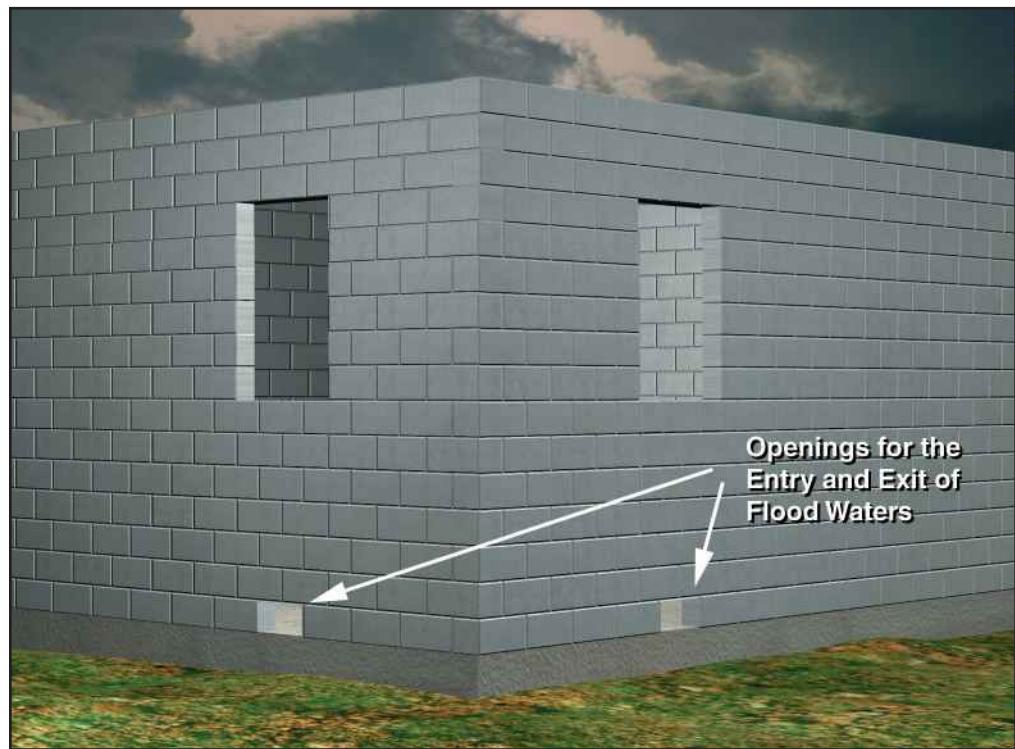
Openings are created in the walls near the ground.

Blocks are removed from the walls of the house at selected locations within 1 foot of the ground (Figure 12). The resulting openings will allow flood waters to flow into and out of the lower area of the house so that the water pressures on both sides of the walls will remain the same. The roof and windows are then replaced, and a new wood-frame floor is constructed above the flood level (Figure 13).

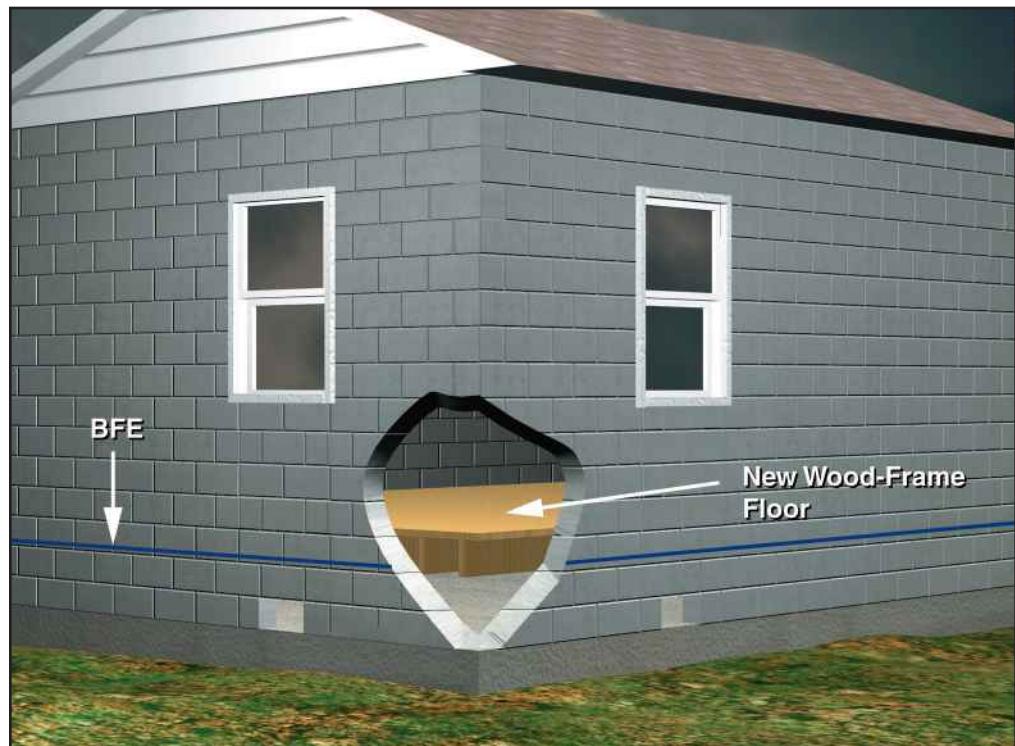
**Figure 13**

A new wood-frame lowest floor is constructed above the flood level, and the roof, windows, and doors are reinstated.

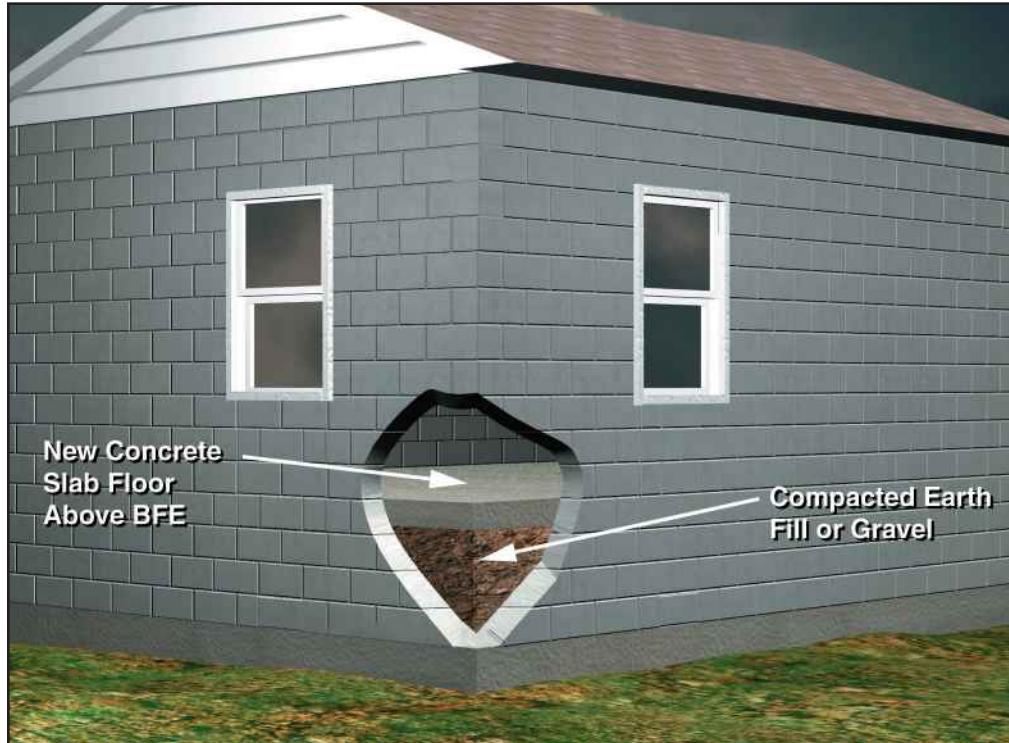
Figure 14
An alternative to building an elevated wood-frame floor is installing a new, elevated concrete slab floor on fill placed over the old slab.

A homeowner who chooses Technique 1 may decide to build a new concrete slab floor instead of a wood floor (Figure 14). When this option is chosen, compacted fill dirt or gravel is placed on top of the old slab and the new slab floor is poured on top. Because the area below the new floor is filled with dirt or gravel, wall openings are not required.

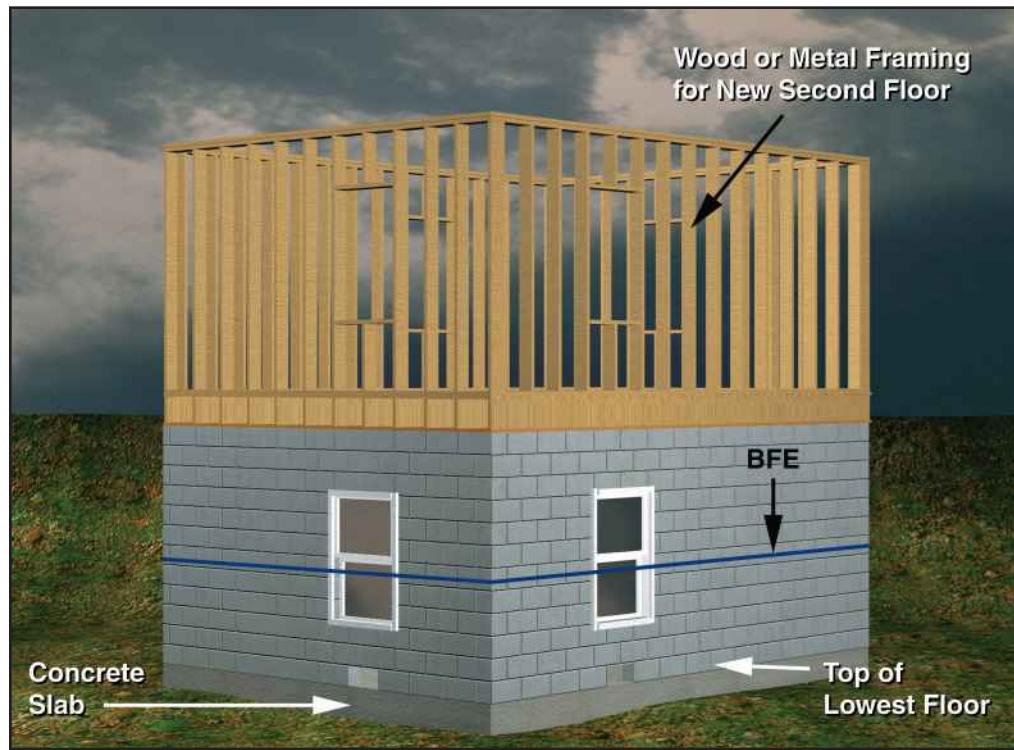
The new second-story floor and walls are built on top of the existing lower story.

As in Technique 1, the repairs begin with the temporary removal of the roof and roof framing (Figure 10). After the roof is removed, construction of the new second story begins. First, a new wood-frame floor is built on top of the existing lower-story walls. The second-story walls are framed with metal or wood studs and set in place on the floor (Figure 15).

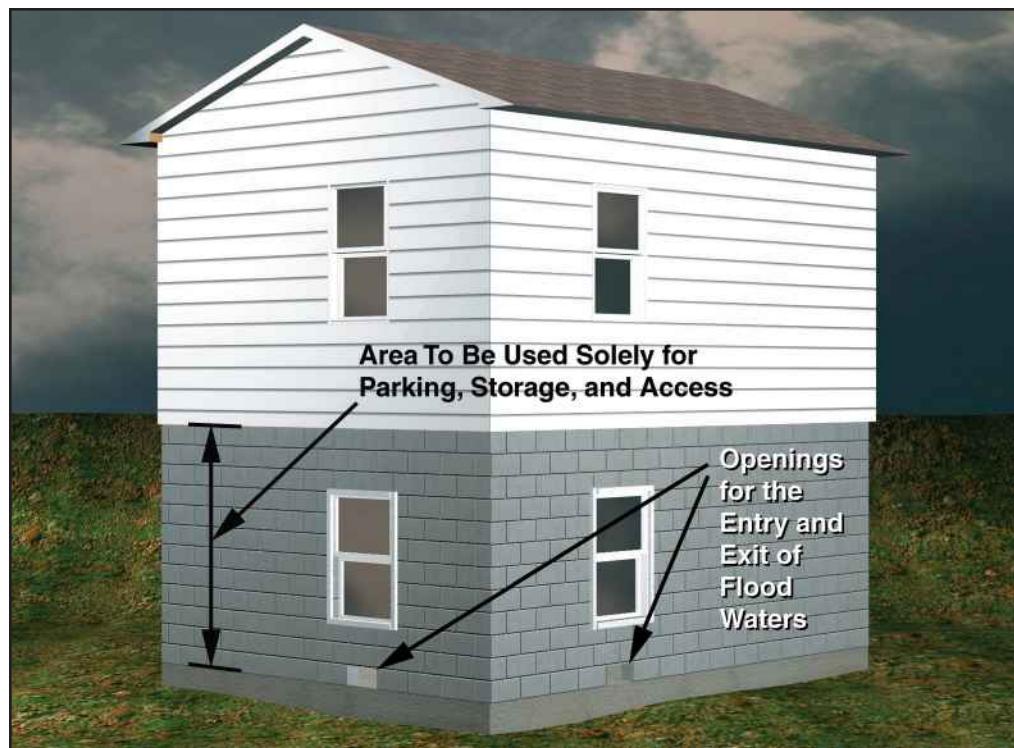
The new second-story walls are covered with siding or stucco.

Some homeowners prefer that the second story be constructed of masonry, but wood- or metal-framing is more common, primarily because it is lighter and less expensive. The roof is replaced, and blocks are removed from the walls to allow flood waters to enter and exit. Exterior sheathing is then added to the framed walls of the second story, the new windows are installed, and siding or stucco is applied to the sheathing (Figure 16).

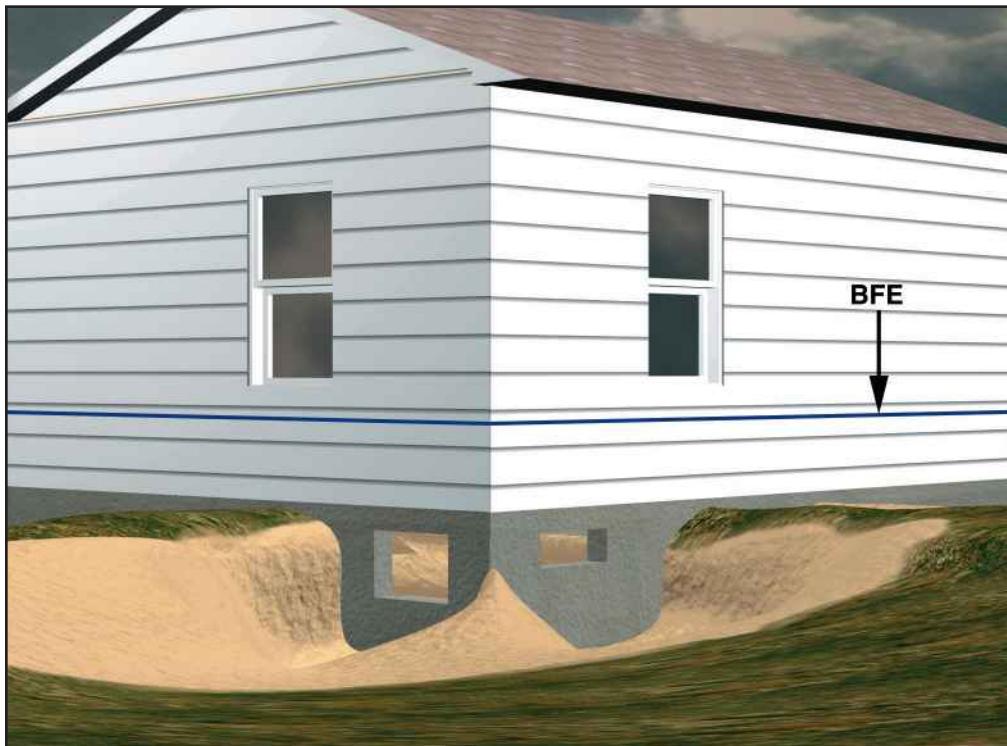
Figure 17
Trenches and tunnels under the slab provide access for the jacks and I-beams that will lift the house.

First, trenches are dug to expose the foundation walls immediately below the slab. Holes are then cut in the foundation walls at intervals around the house, and tunnels are dug under the slab (Figure 17). Jacks are placed in the trenches and large I-beams are inserted through the tunnels and allowed to rest on the jacks. Smaller I-beams are then inserted through the tunnels at right angles to the larger beams and positioned on top of them. The smaller beams support the slab when the house is raised (Figure 18).

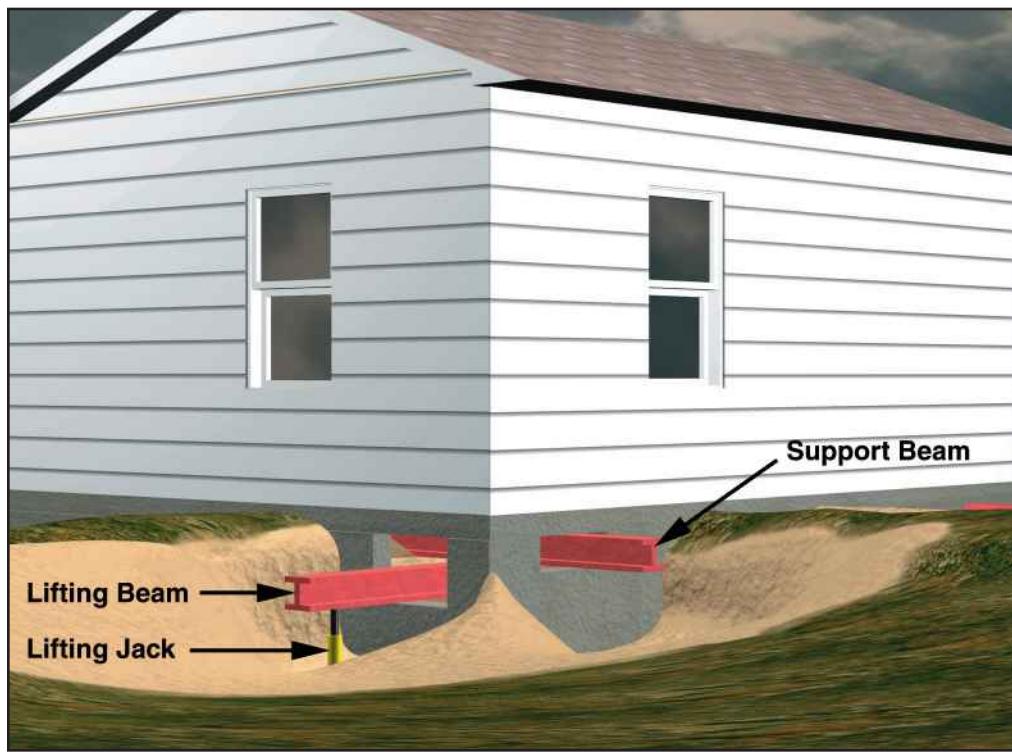
Figure 18

With I-beams and jacks in place, the house is ready to be lifted.

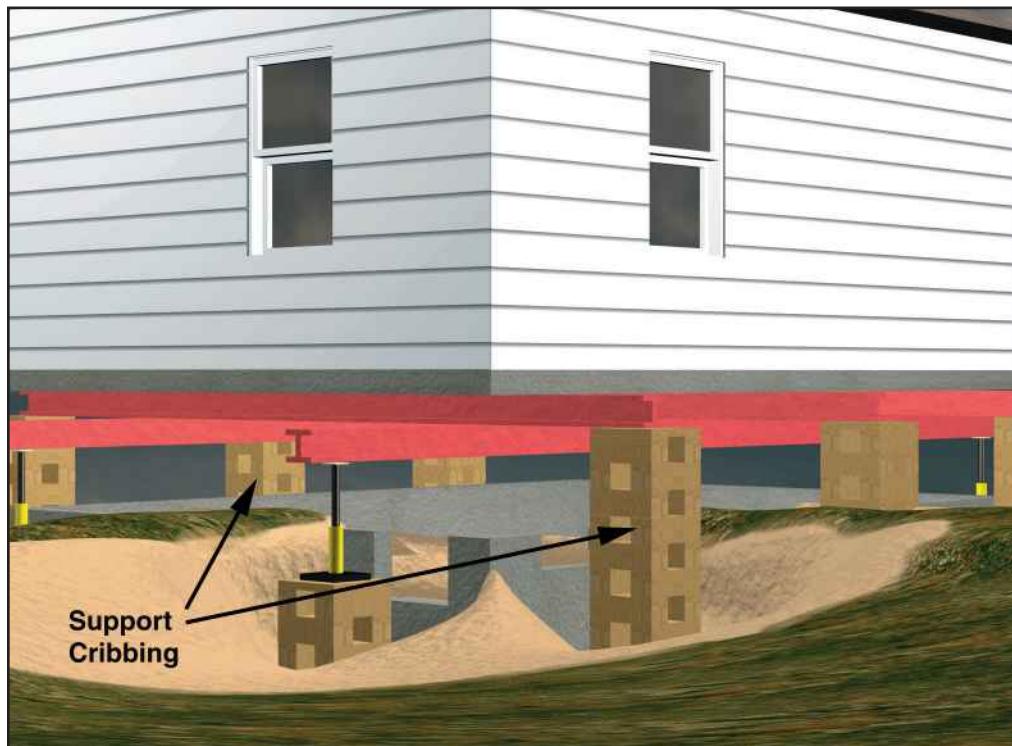
The house is temporarily supported on cribbing.

The house is then jacked up. When the jacks have extended as far as possible, the house must be supported temporarily while the jacks are raised. Both the house and the jacks are usually supported on “cribbing”—temporary piles of crisscrossed timbers (Figure 19). The jacks are then used to raise the house higher.

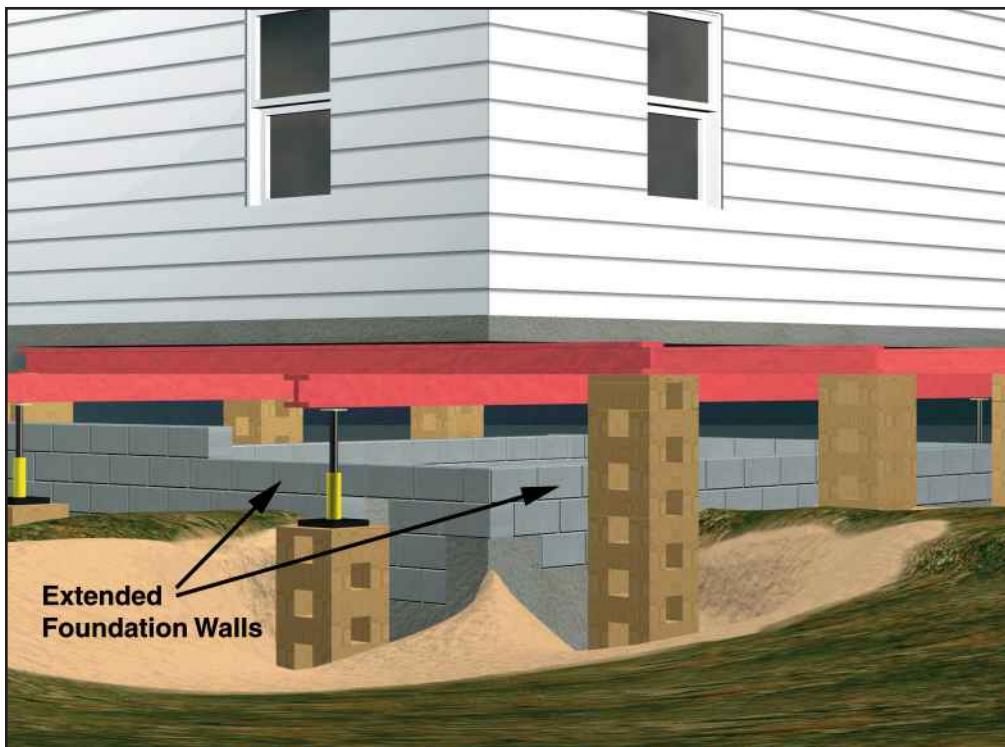
Figure 20
New, extended foundation walls are constructed with concrete blocks.

This process is repeated until the house is raised to the desired height. The foundation walls are then extended upward with additional rows of concrete block (Figure 20). As in the previous techniques, openings are made in the walls within 1 foot of the ground so that flood waters will be able to flow into and out of the area below the elevated floor. The jacks and beams are removed, and the openings left around the beams are filled with blocks (Figure 21).

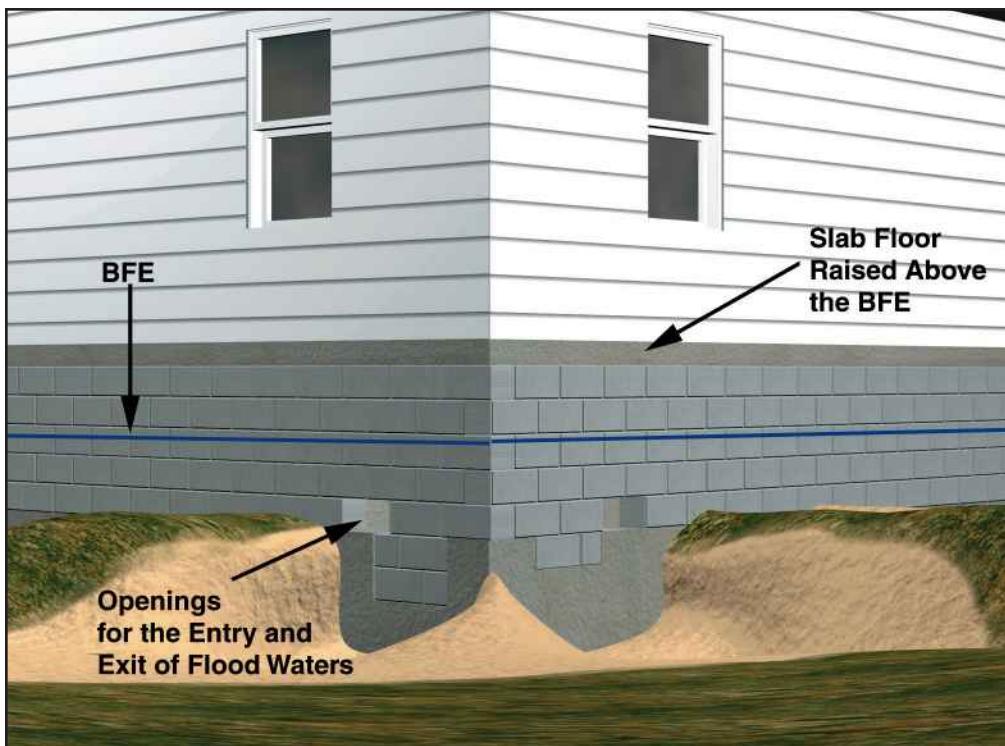
Figure 21
Elevated house and slab on new, extended foundation walls.

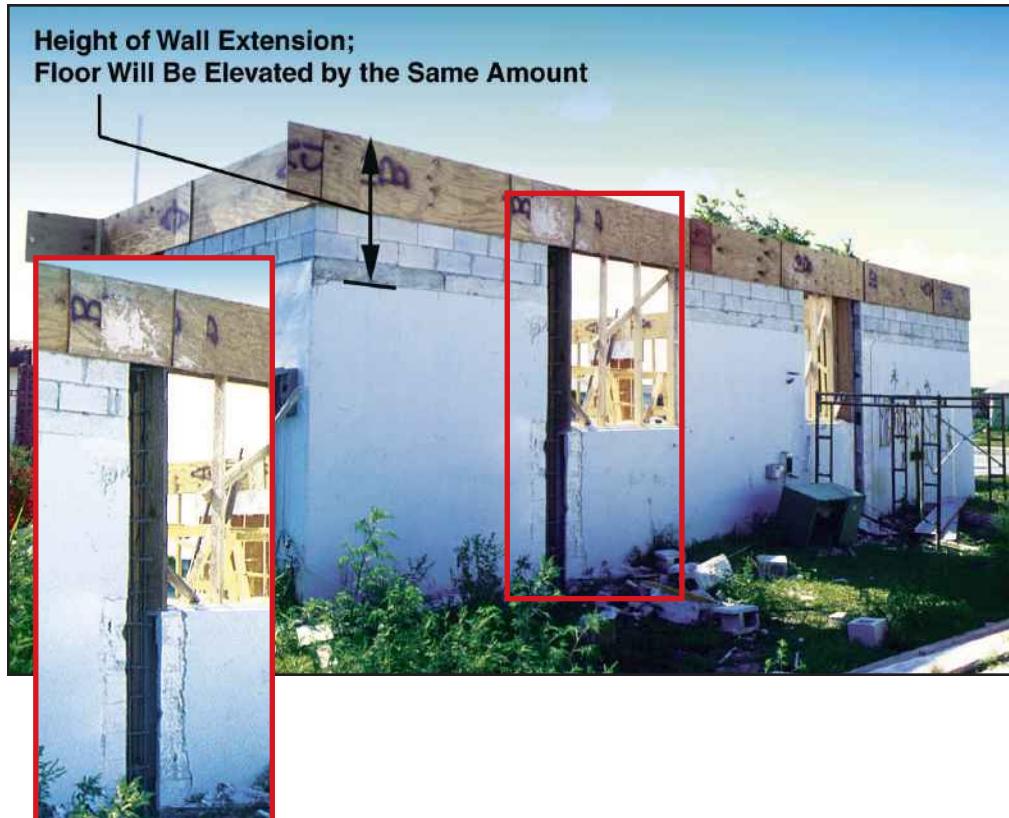
Another view of the extended walls. The vertical cuts in the walls next to the windows are for concrete tiedown columns that will be cast in place to further strengthen the extended walls against wind loads. The owner of this house was able to meet the elevation requirement by raising the floor only a few feet, as indicated by the amount that the walls have been extended.

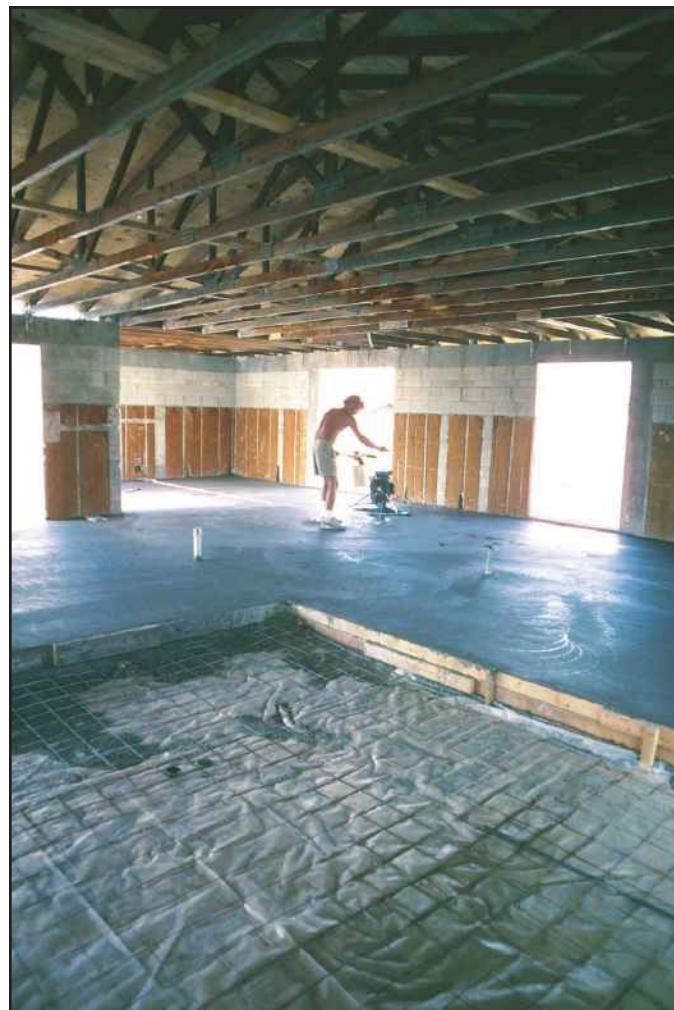
The roof has been rebuilt with the salvaged trusses, and most of the new concrete slab has been poured on top of the sand fill. The open area in the foreground, where plastic sheeting and wire reinforcement can be seen on top of the sand fill, is where the remaining part of the slab will be poured.

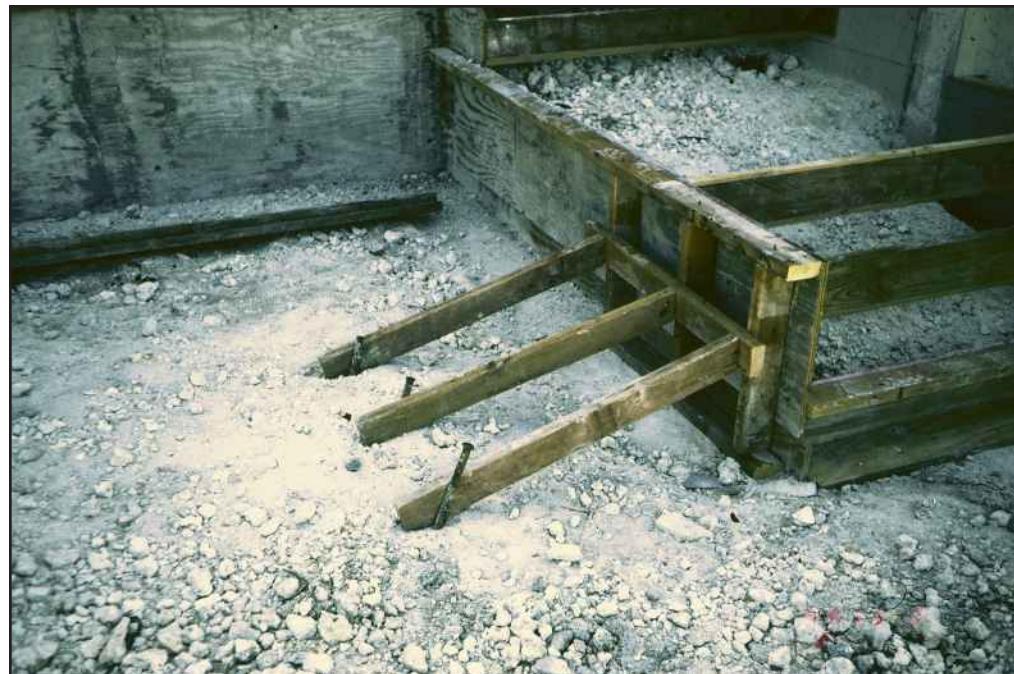
Wood framing for a new concrete staircase that will provide access to the elevated floor.

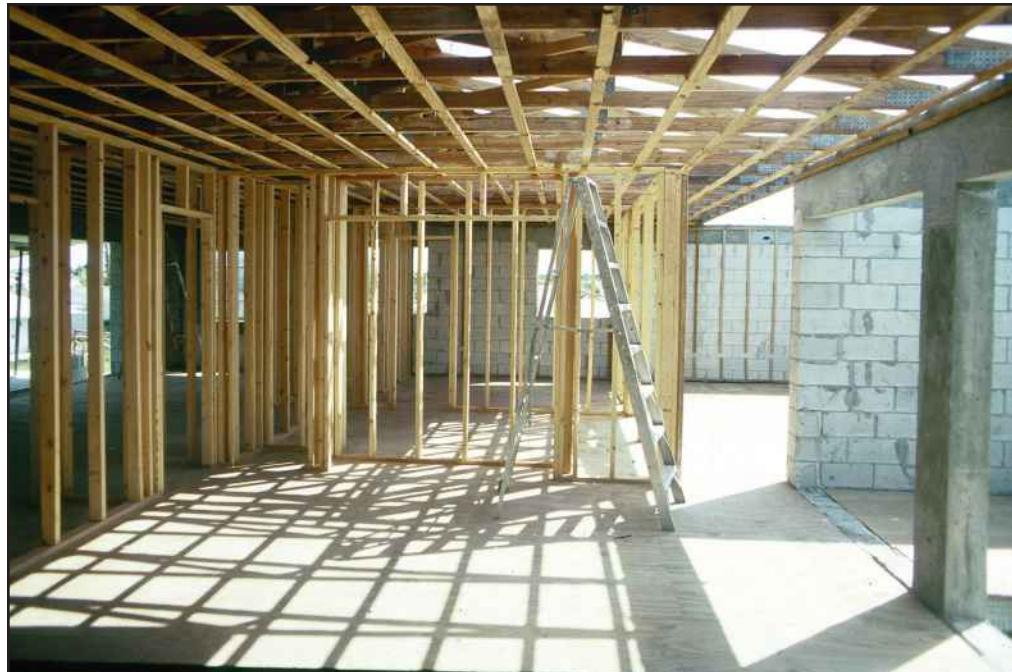
After the new concrete slab is poured, wood framing for interior walls is added.

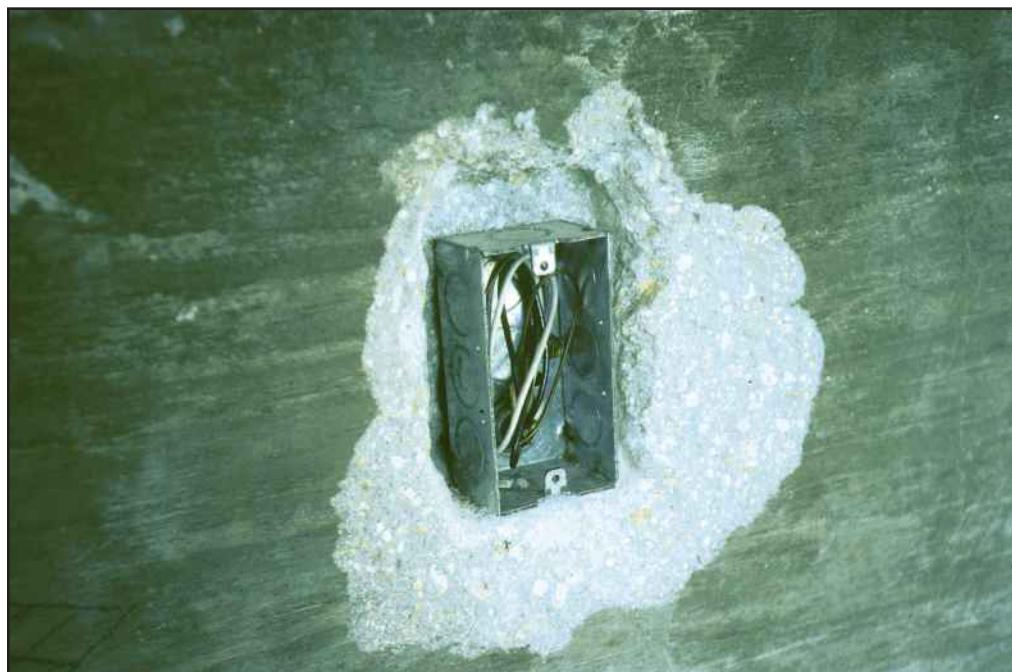
The electrical system is upgraded to meet current code requirements.

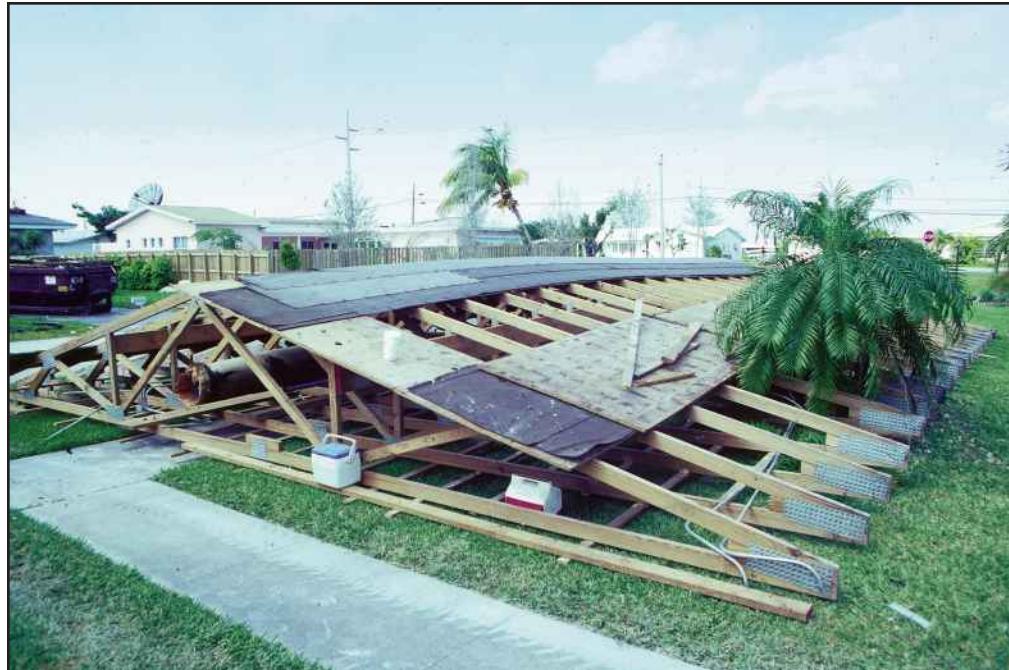
The roof of this house was removed as a single piece; the trusses were held together with bracing and portions of the original roof sheathing. This approach made it easier to reinstall the roof at the end of the project.

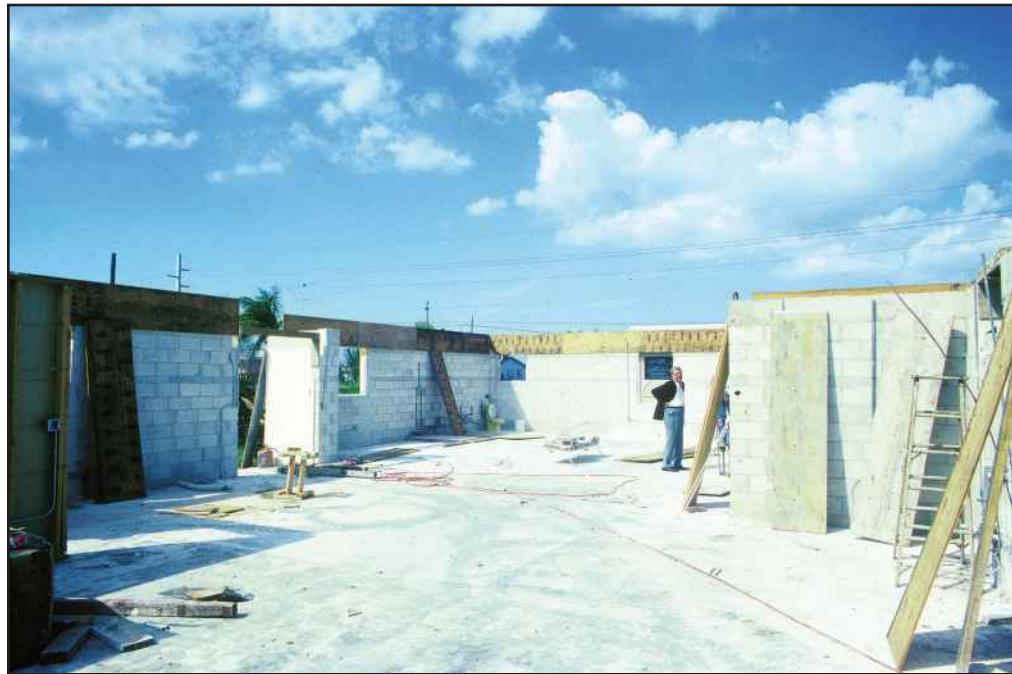
Figure 40

After the roof was removed and the storm-damaged interior gutted, the walls of the house were extended upward and a new bond beam added at the top.

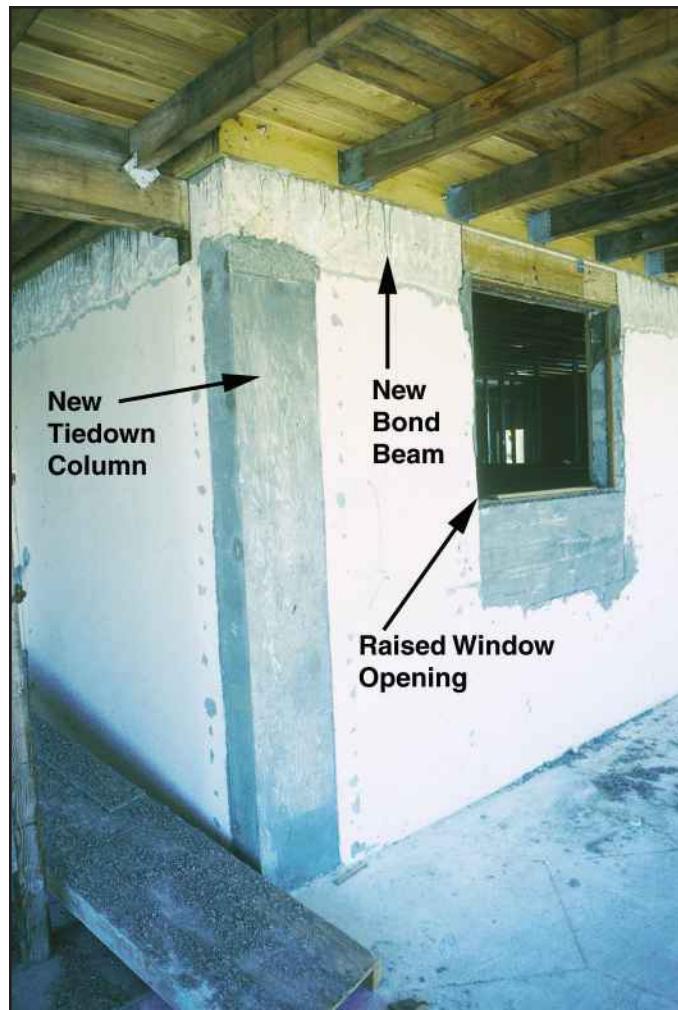
**Figure 41**

Note the new bond beam at the top of the extended wall, the new concrete tiedown column at the corner, and the raised window opening.

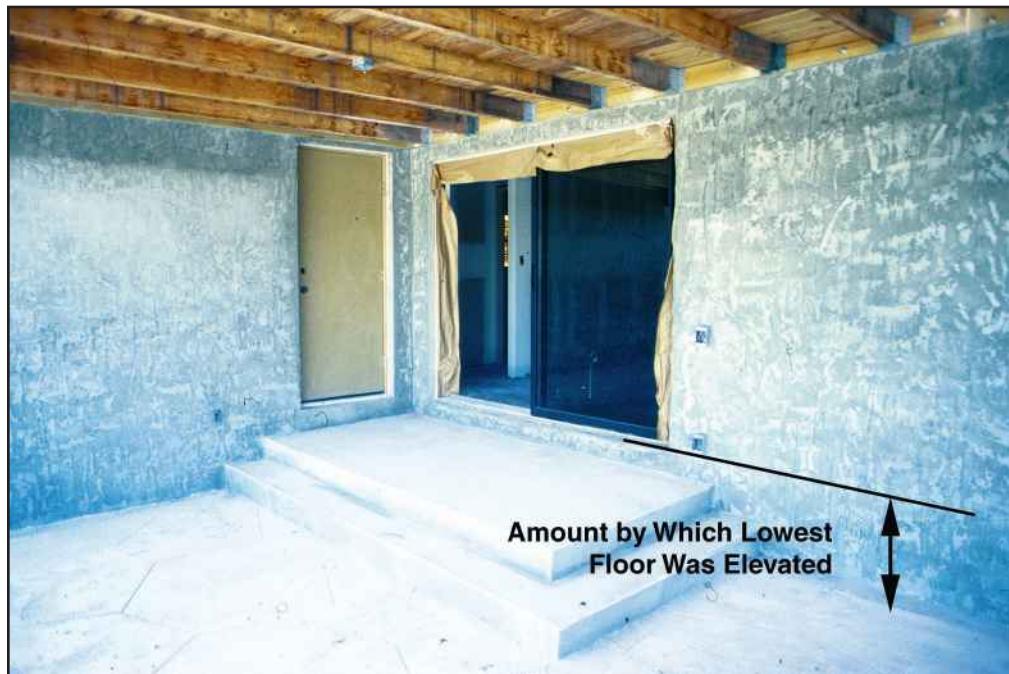
Figure 42

This view from the back of the house shows the height of the elevated slab floor.

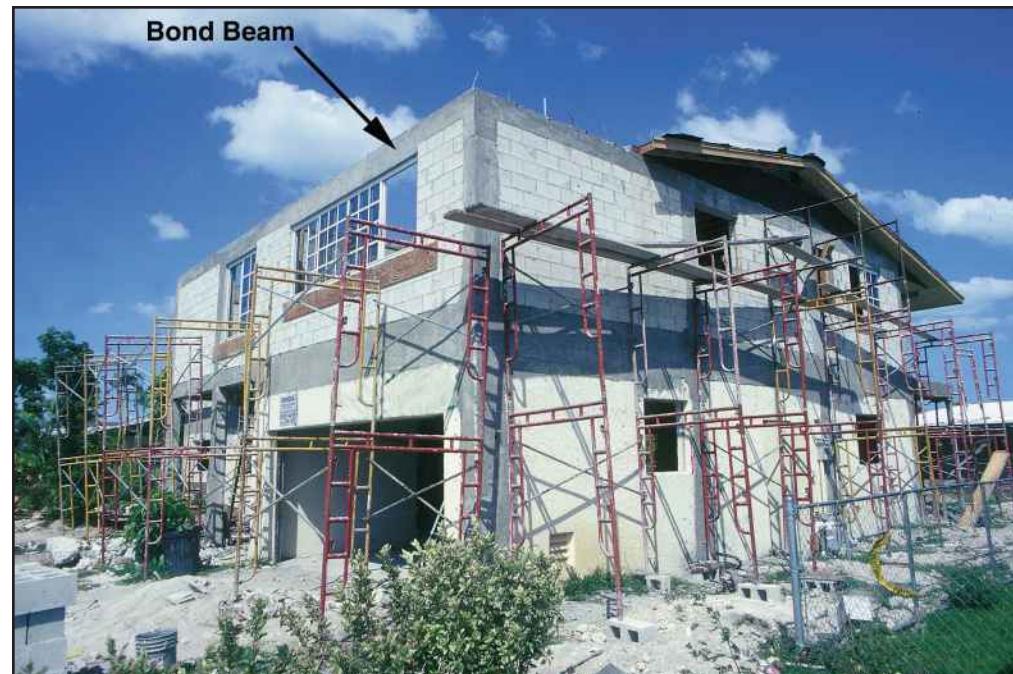
Concrete bond beams similar to those shown earlier were used in this house, but here they were installed on the tops of both the original first-story walls and the new reinforced concrete block second-story walls.

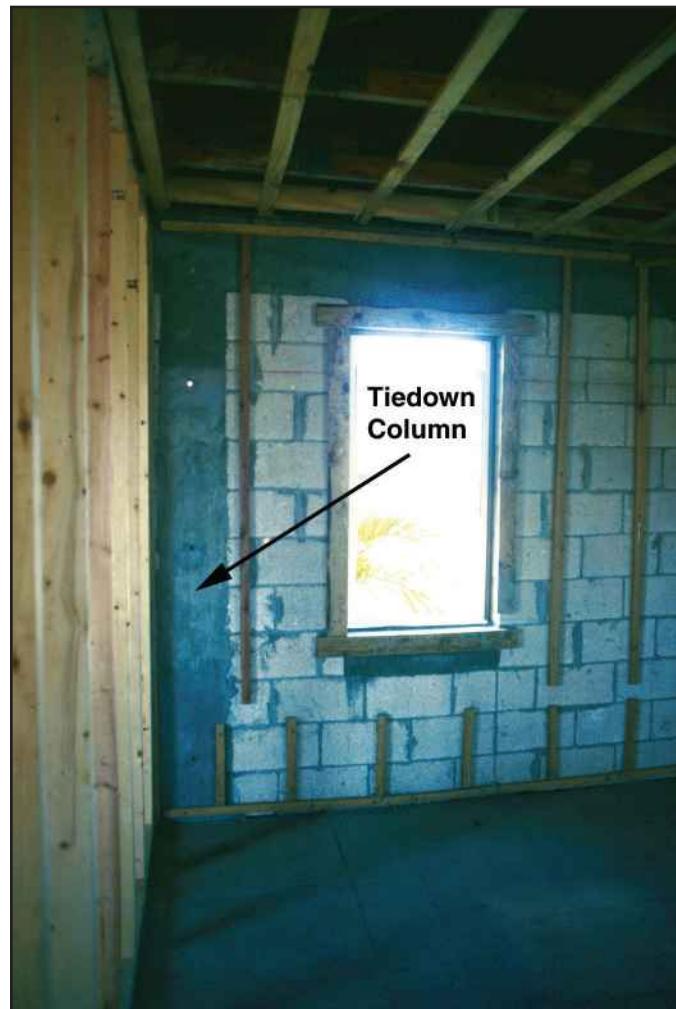
Figure 46
Concrete tiedown
columns, such as the one
to the left of the window
in this photograph, were
also used in this house.

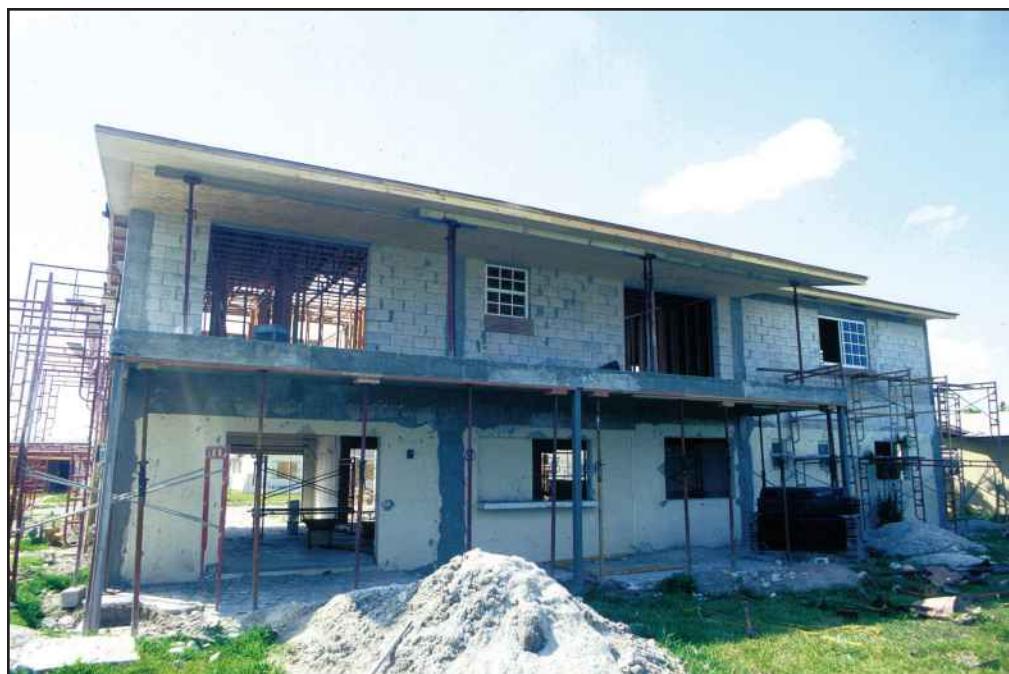
Figure 47
The tiedown columns
extend down from
the new second-story
walls and into the
original first-floor
walls. The columns tie
the first and second
stories together and
provide a continuous
load path that helps
the house resist the
forces of high winds.

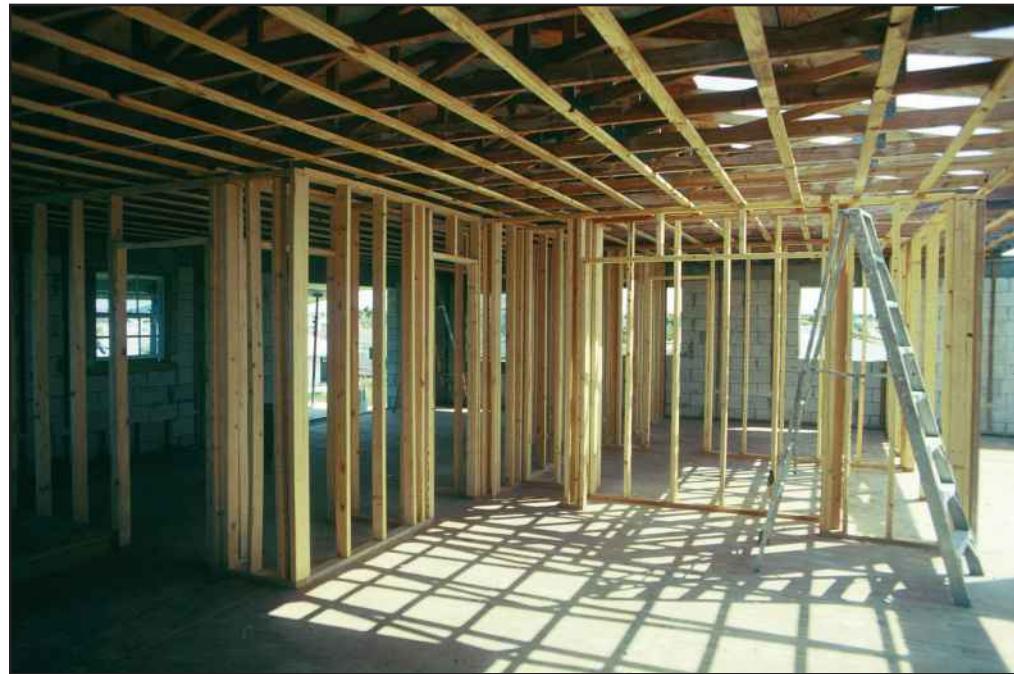
Figure 48

Wood 2 by 4 studs were used to frame the interior walls of the second story.
