Above the Flood: Elevating Your Floodprone House

FEMA 347 / May 2000

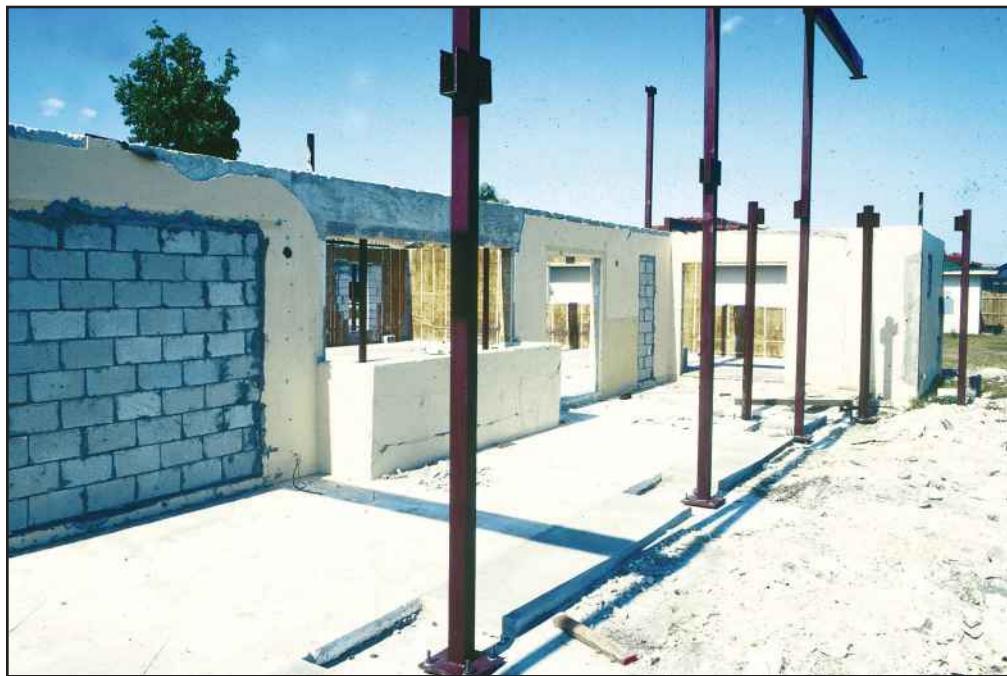
The existing first-story walls have been strengthened by the addition of concrete block. Metal columns and beams have been added to help support the new second story.

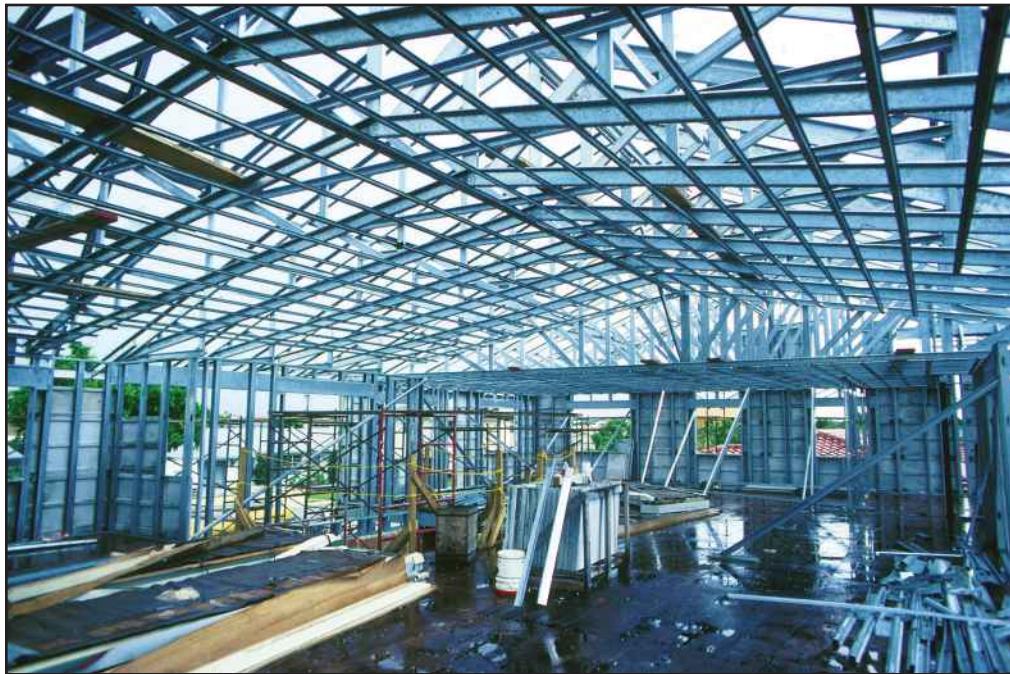
Metal framing is used for the new second story, including the walls and roof support system.

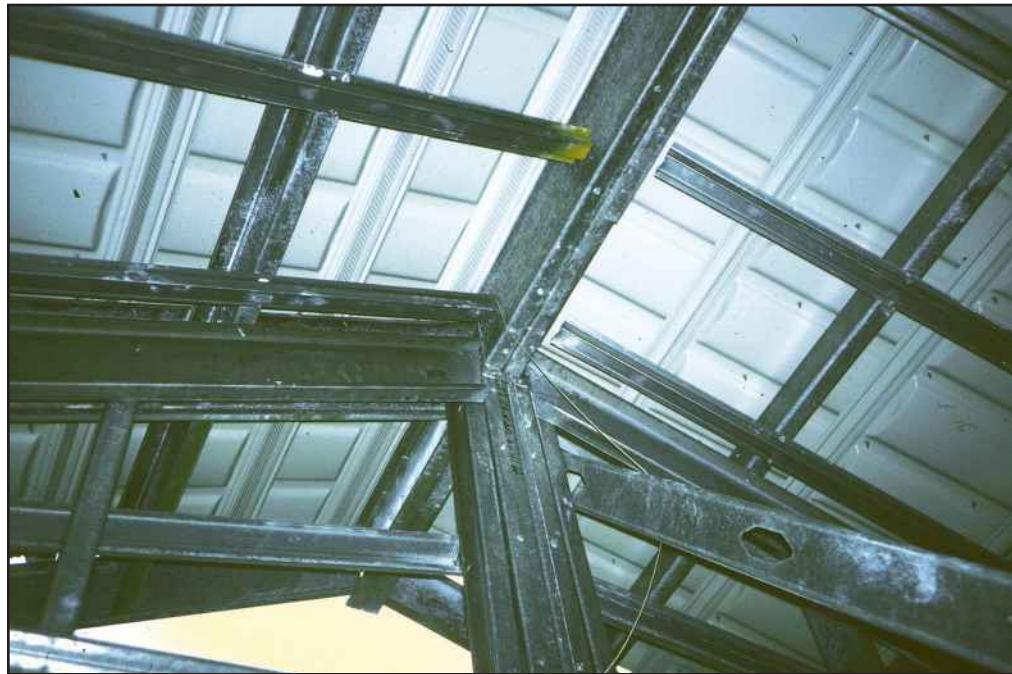
One advantage of metal framing is its relatively light weight. An additional advantage is that the screws used to attach metal-frame components provide strong connections.

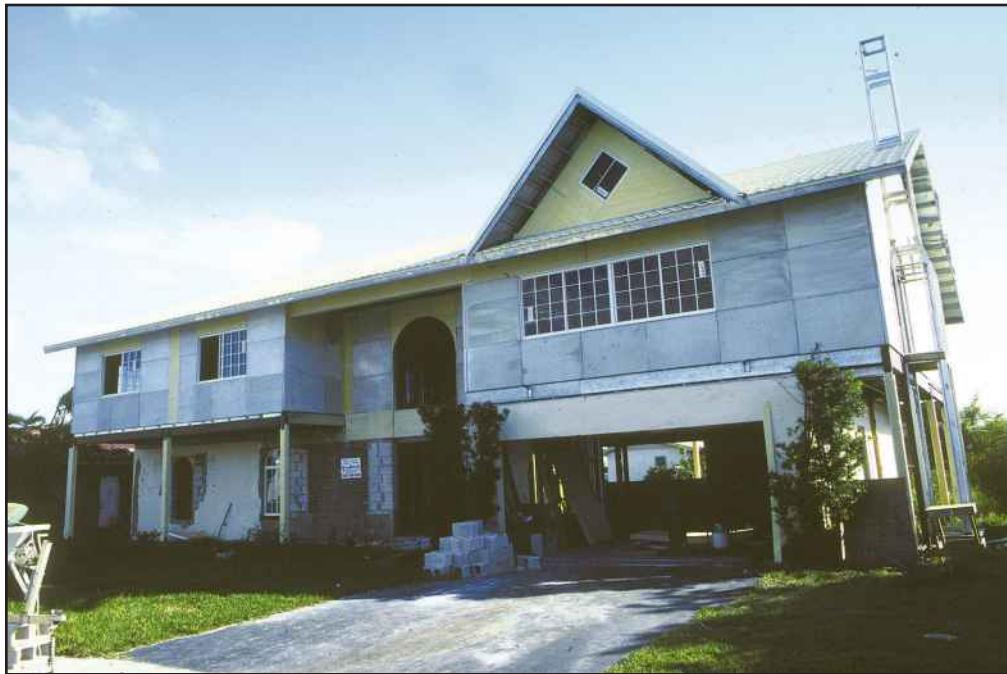
Figure 58

The new second story nears completion. The roof is made of formed metal panels.

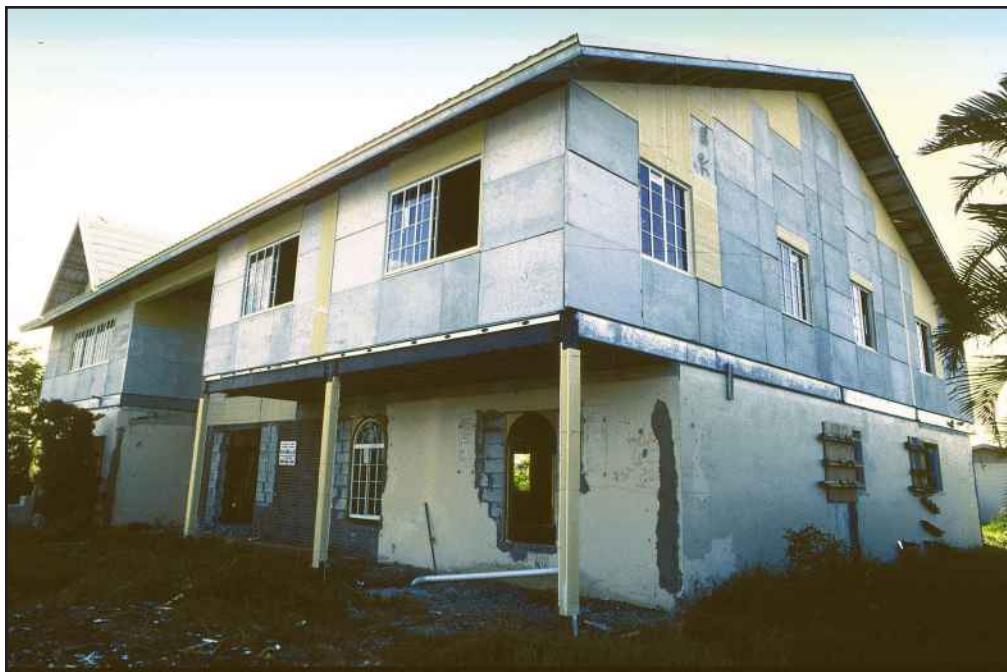
Figure 59

The exterior walls consist of prefabricated concrete panels. Innovative techniques such as those employed in this project are helping homeowners who need practical and economical methods of repairing and protecting their houses.

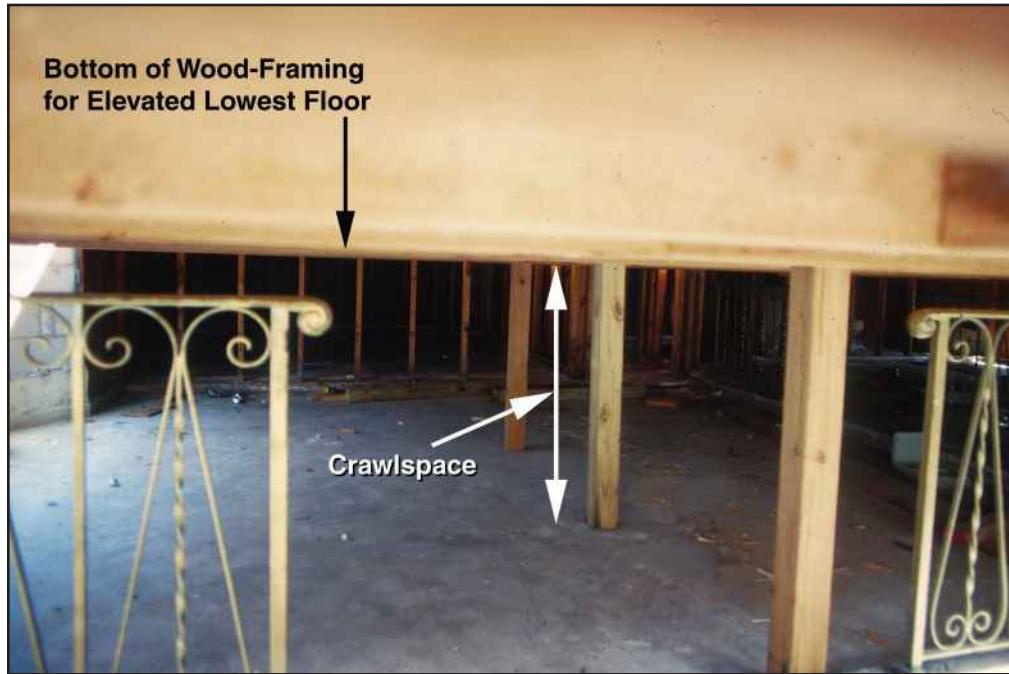
Figure 68

Rather than install a new concrete slab on compacted fill, the owner of this house chose to build a new wood-frame floor above the old concrete slab. This method creates a crawlspace below the new floor.

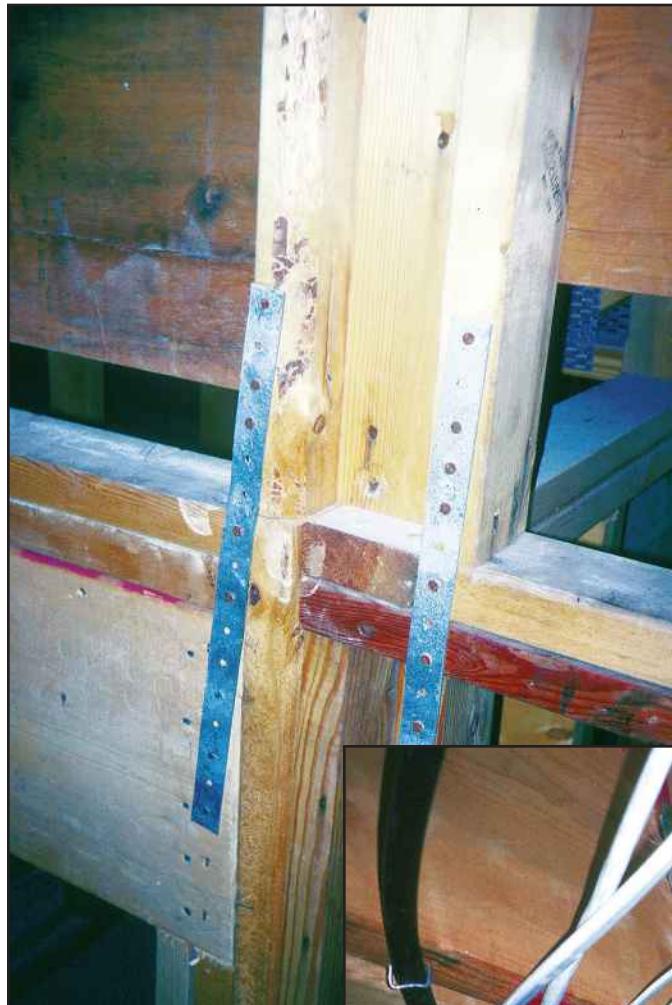
Figure 70

Metal hurricane straps are used to tie the structural members together and create a continuous load path from the roof to the foundation.

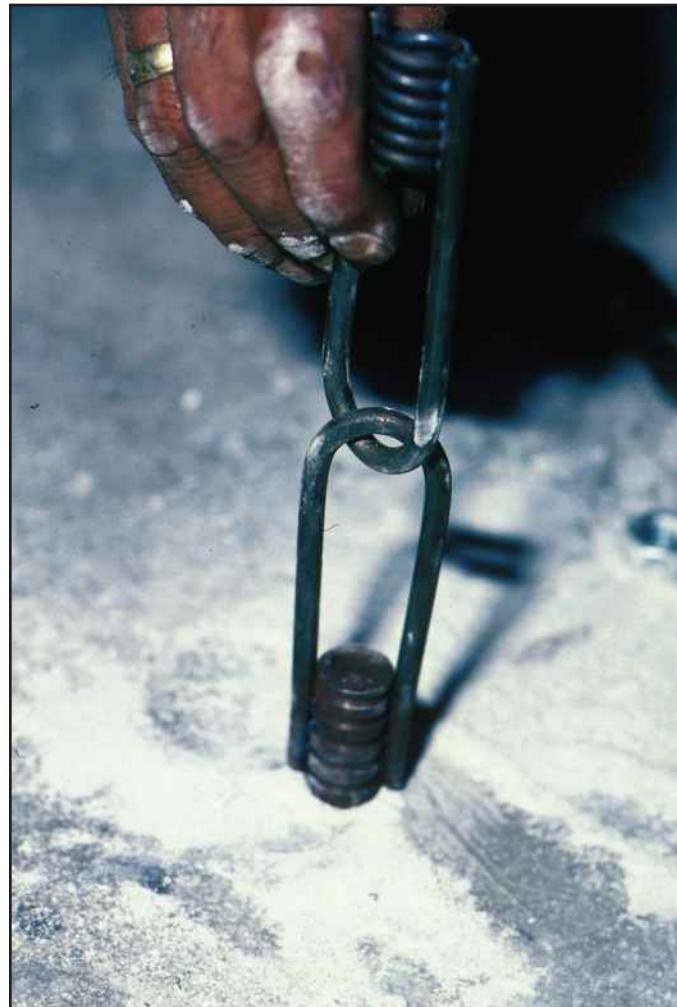
... and use hangers to attach the anchors to the grid of steel beams.

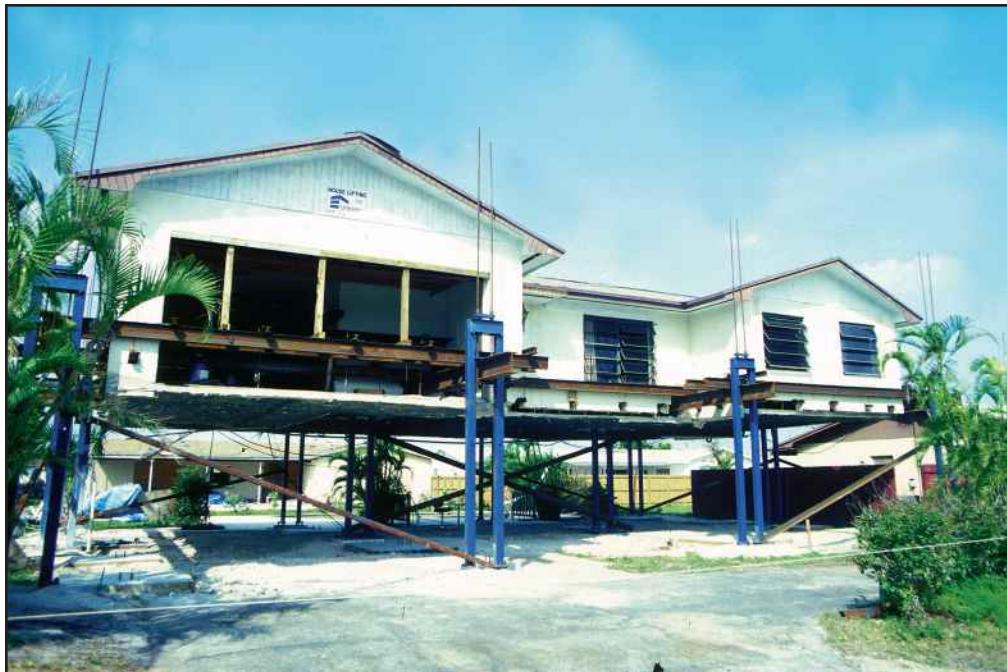
The house and slab were raised one full story.

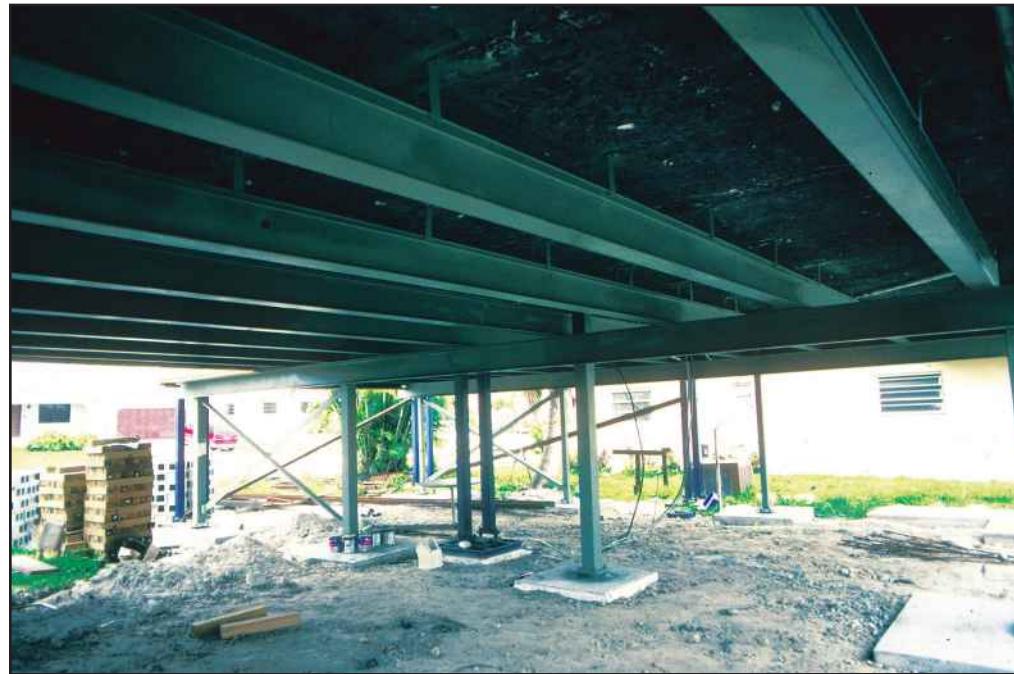
Figure 82

While the jacks and beams supported the house, new steel foundation members were installed below.
